Complaints about vibration-induced noise from the underground metro line in Amsterdam

Edwin Nieuwenhuizen

Rail Technology Conferences 2014
Düsseldorf

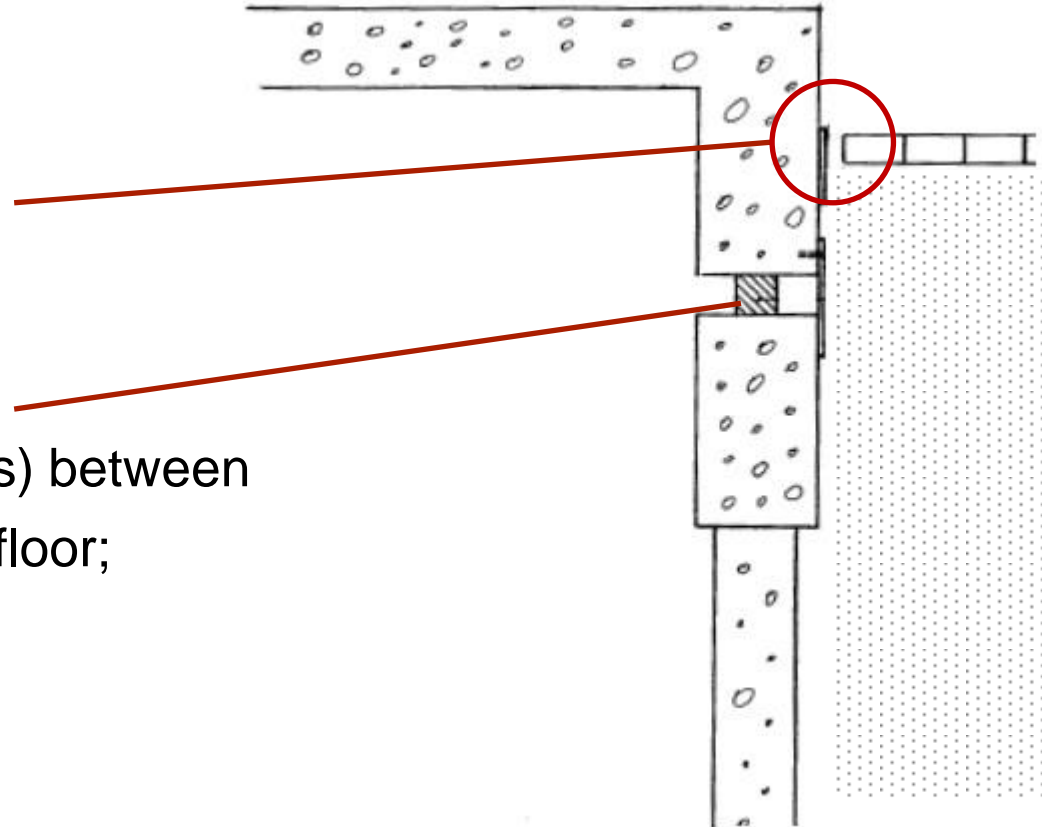
Amsterdam Pentagon building

no contact between
pavement and facades

rubber isolator pads (609 pcs) between
basement walls and ground floor;
no rigid joints (e.g. piping)

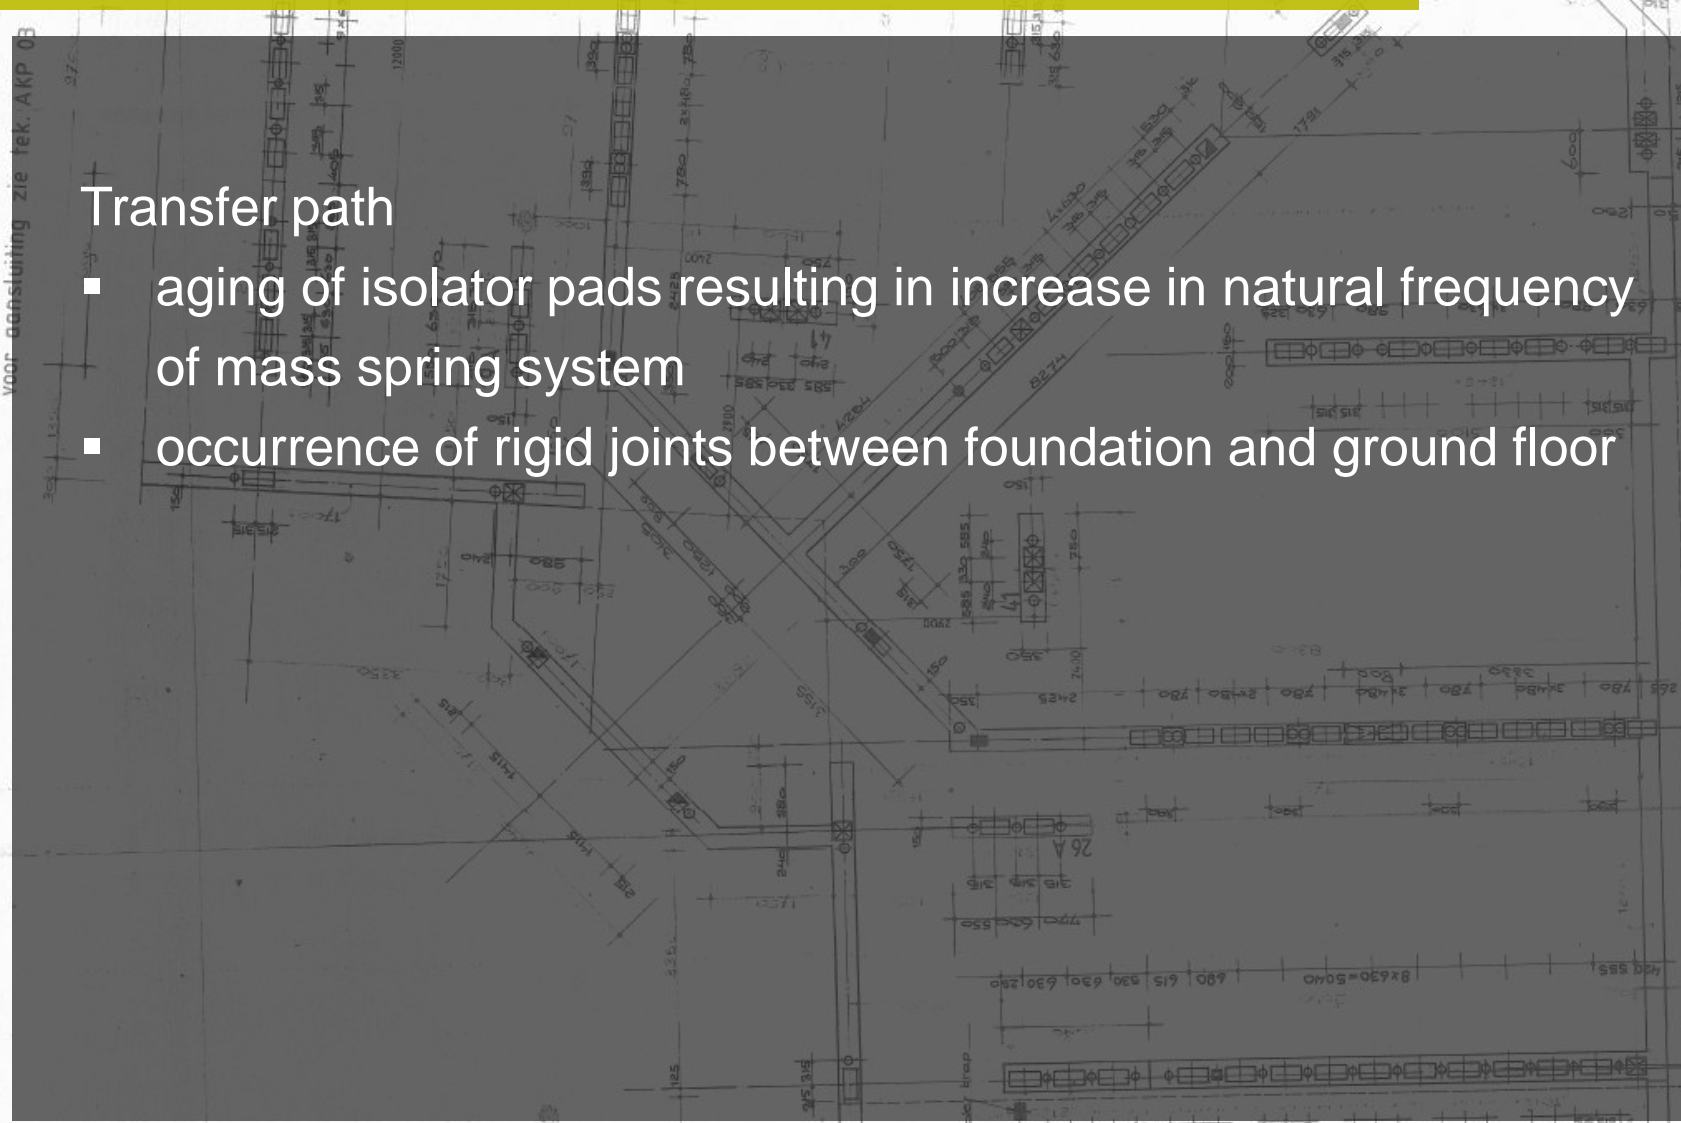
Possible causes of nuisance (2/3)

- aging of isolator pads resulting in increase in natural frequency of mass spring system
- occurrence of rigid joints between foundation and ground floor

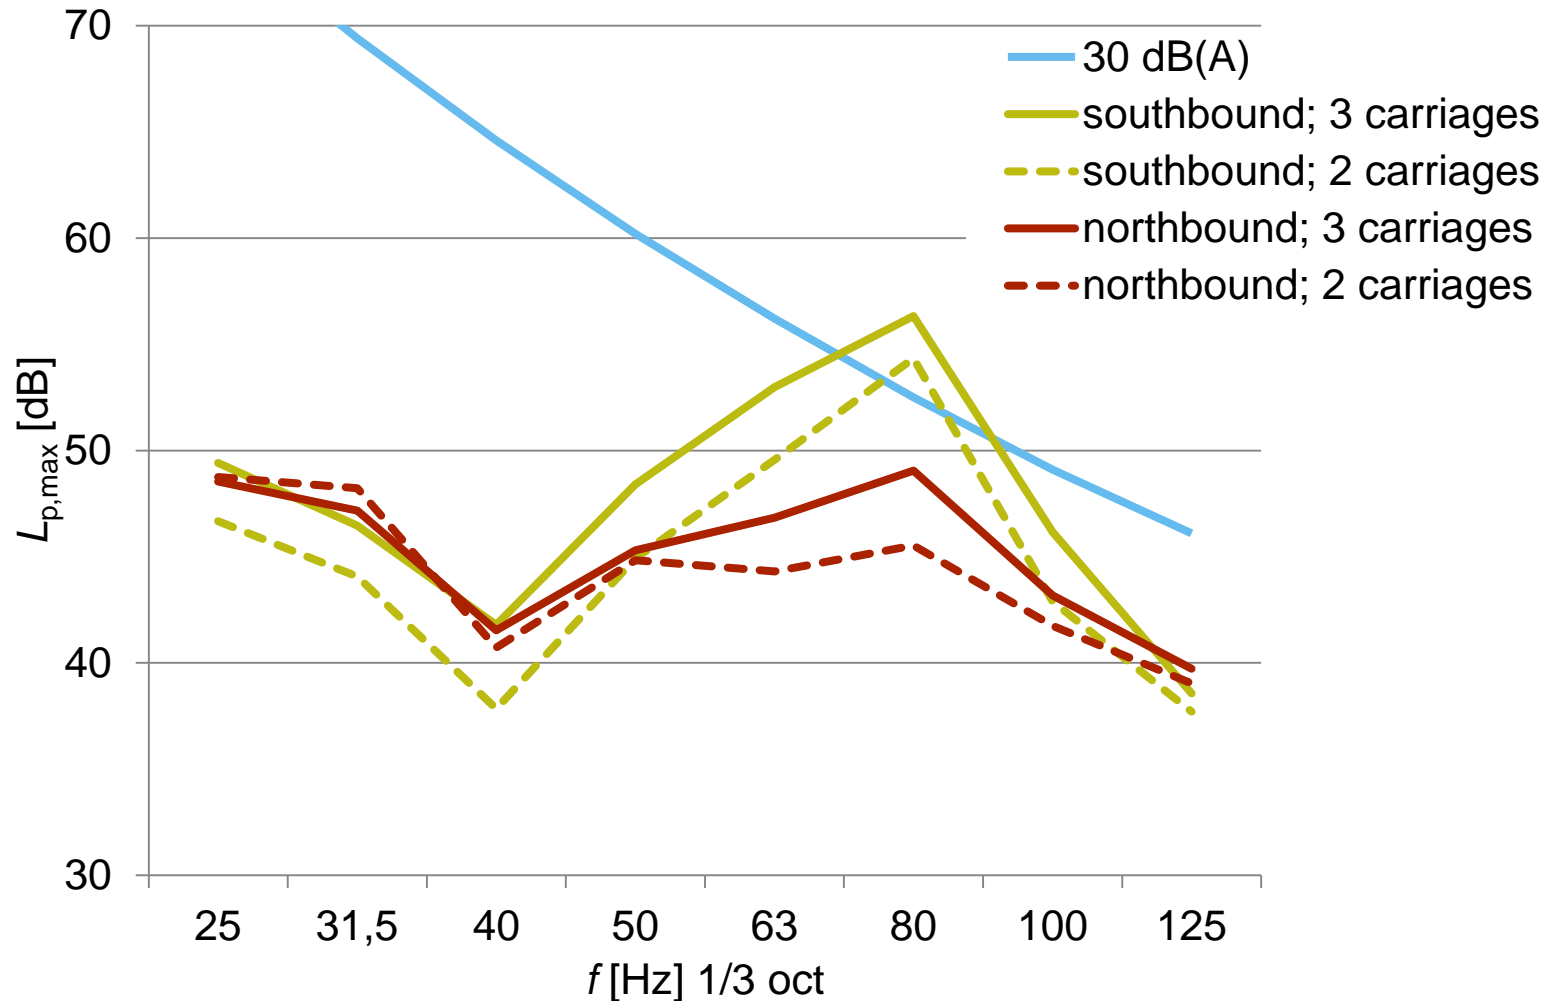
Measurements in residential space (2/2)

- L_{Amax} is higher than 30 dB(A) limit
- 80 Hz 1/3 octave band is predominant and responsible for nuisance
- pass-by on southbound track noisier than vice versa (+8 dB)
- metros with 3 carriages noisier than with 2 (+2 dB)
- wall vibration level matches noise level: no airborne transfer path

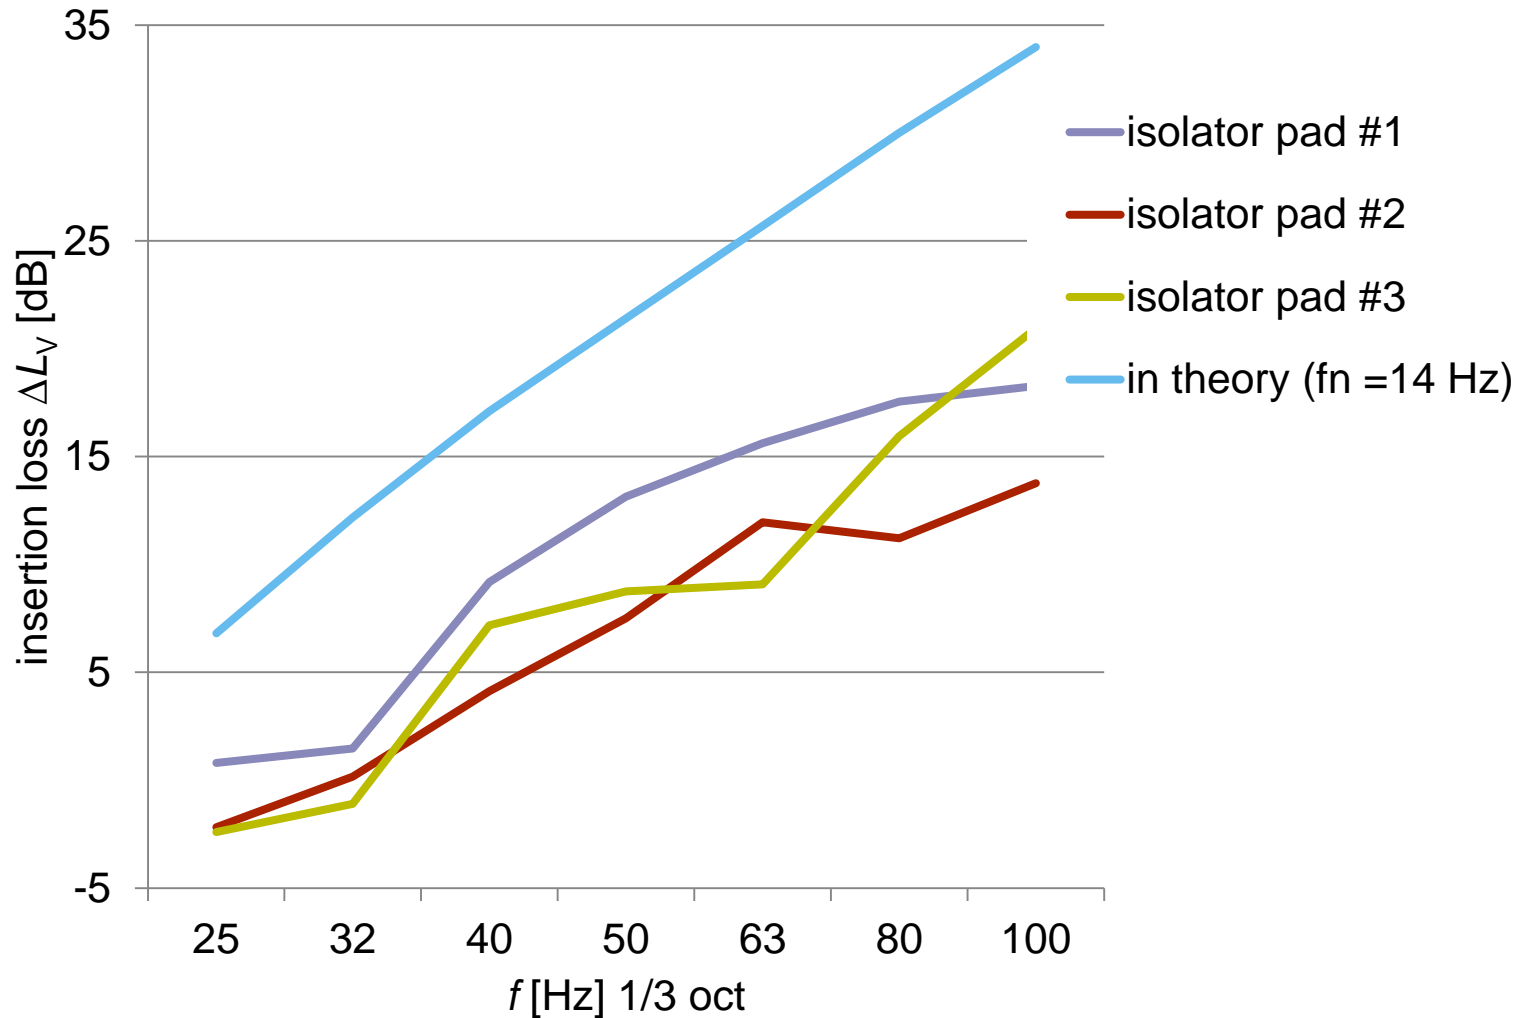
Measurements in basement (2/3)

- quick inspection revealed possible deviations:
 - not all isolator pads are load bearing
 - flexible joints between non-bearing walls and ground floor are not visible (rigid contacts?)
 - no gap between pavement and facade
- in situ measured insertion loss of rubber pads is about 15 dB at 80 Hz
- vibration levels on ground floor highest above supposed non-bearing walls and near facades (reveals a vibration bypass)

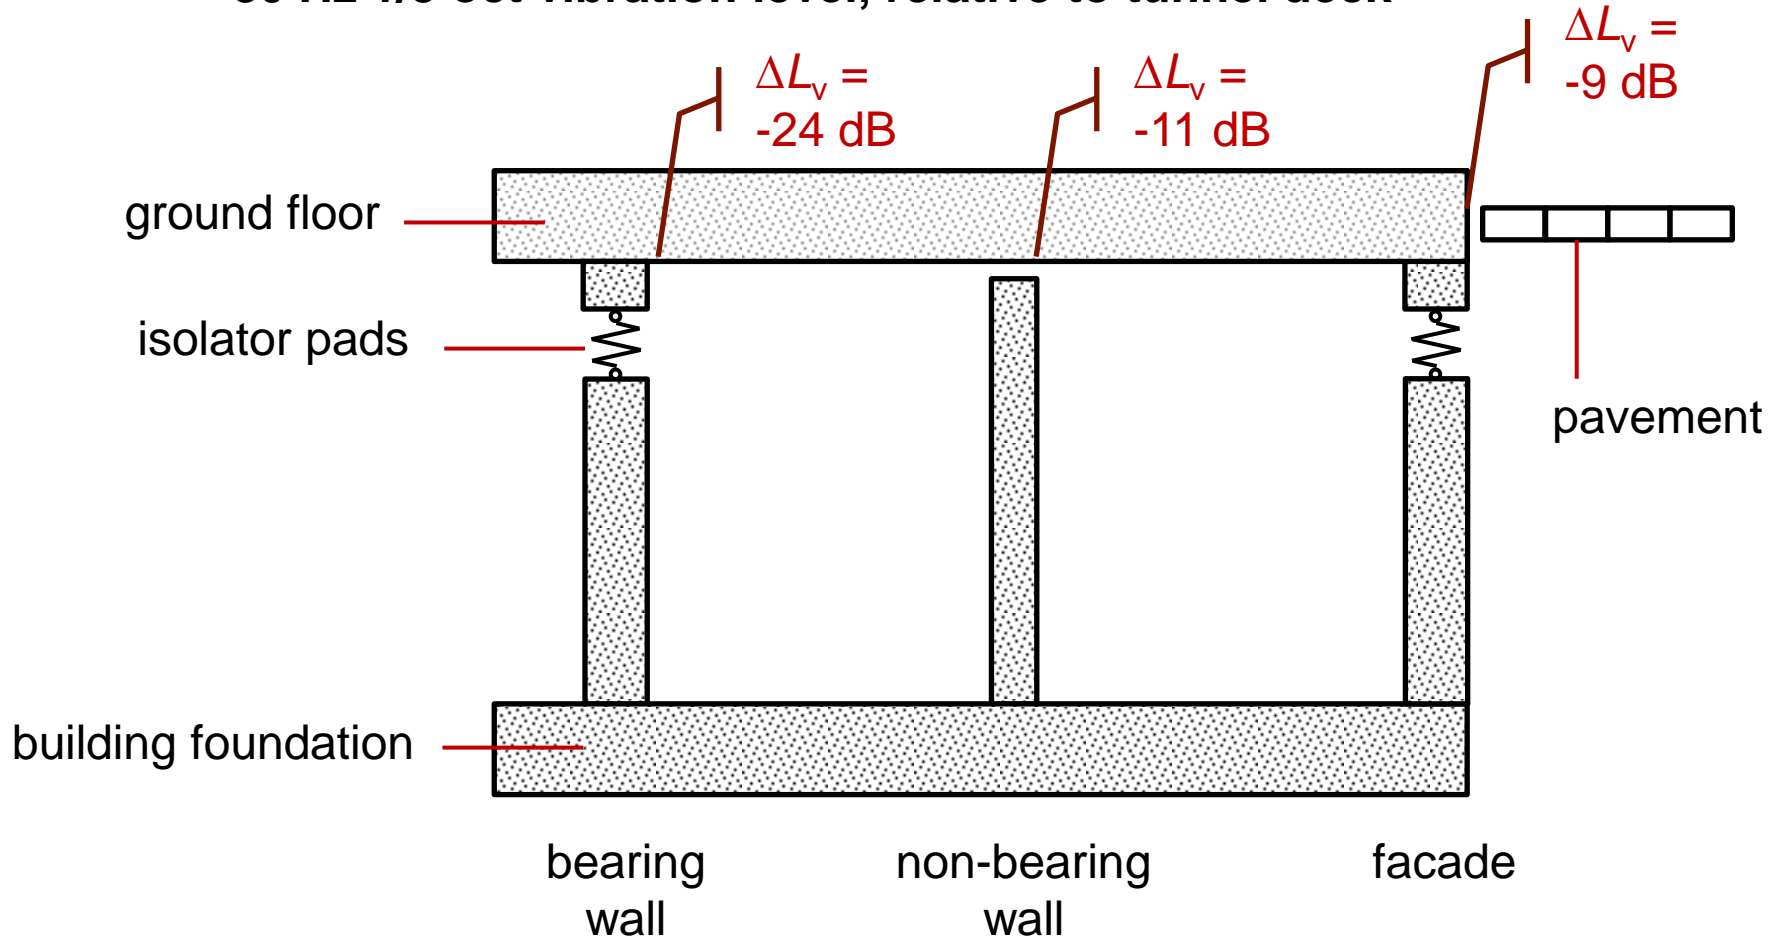
Measurements in basement (3/3)

80 Hz 1/3 oct vibration level, relative to tunnel deck

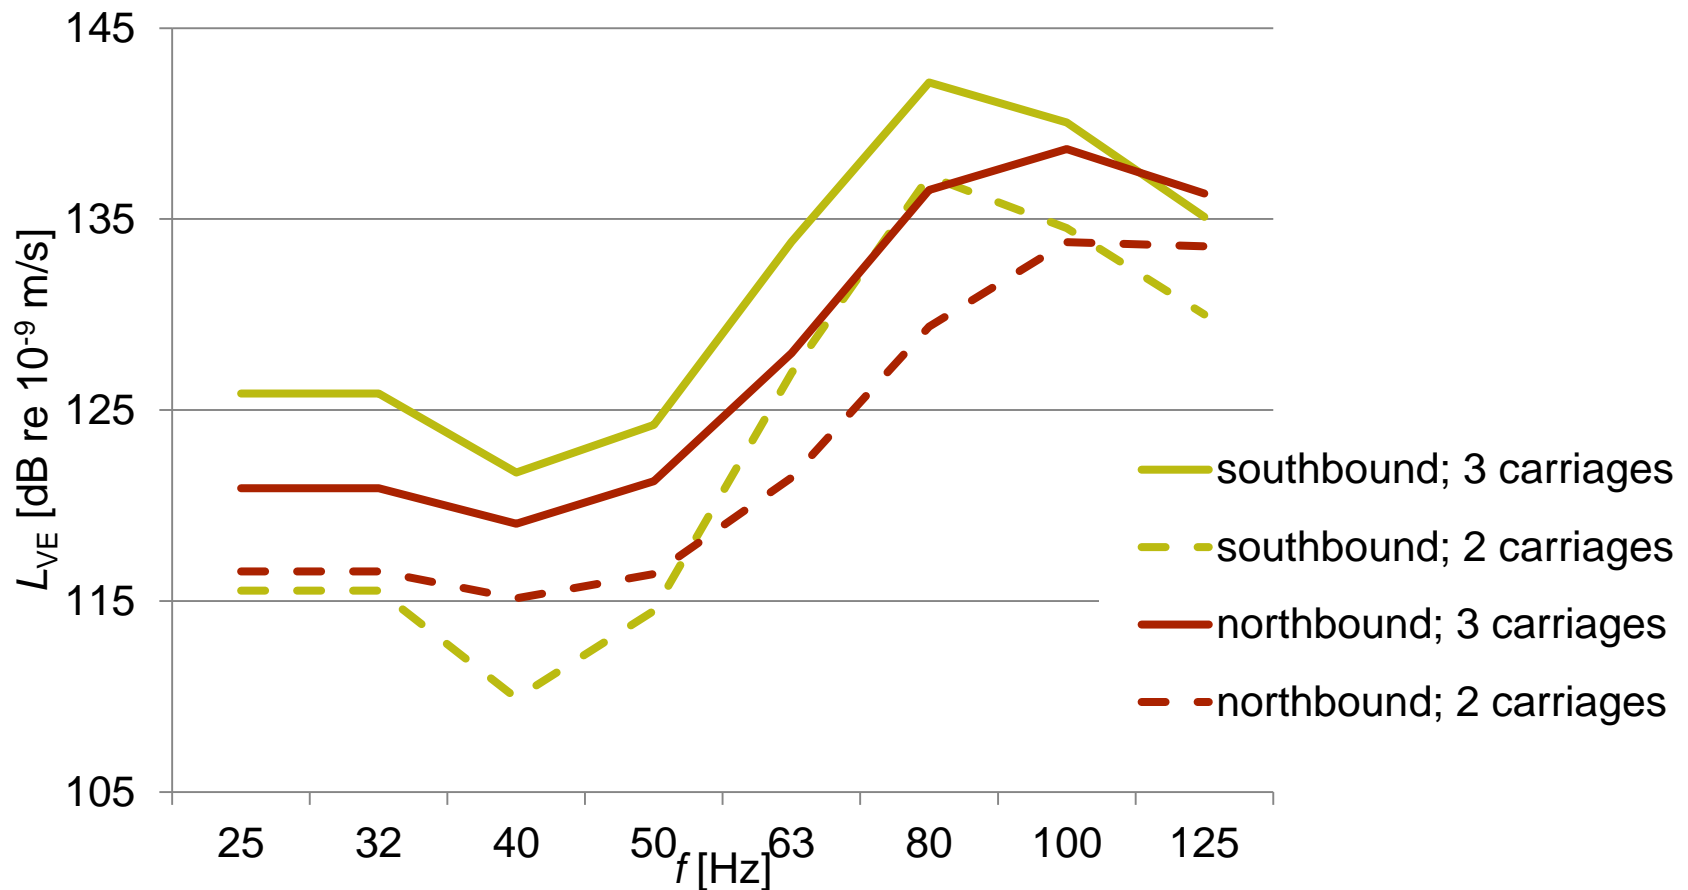
Measurement on rail foot (2/3)

- metros with 3 carriages cause higher vibration levels than with 2 carriages
- average vibration level of southbound track is higher than northbound
- metros change direction at CS: wheel roughness is probably not the cause
- vertical Track Decay Rates of tracks seem normal

average of inner and outer rail

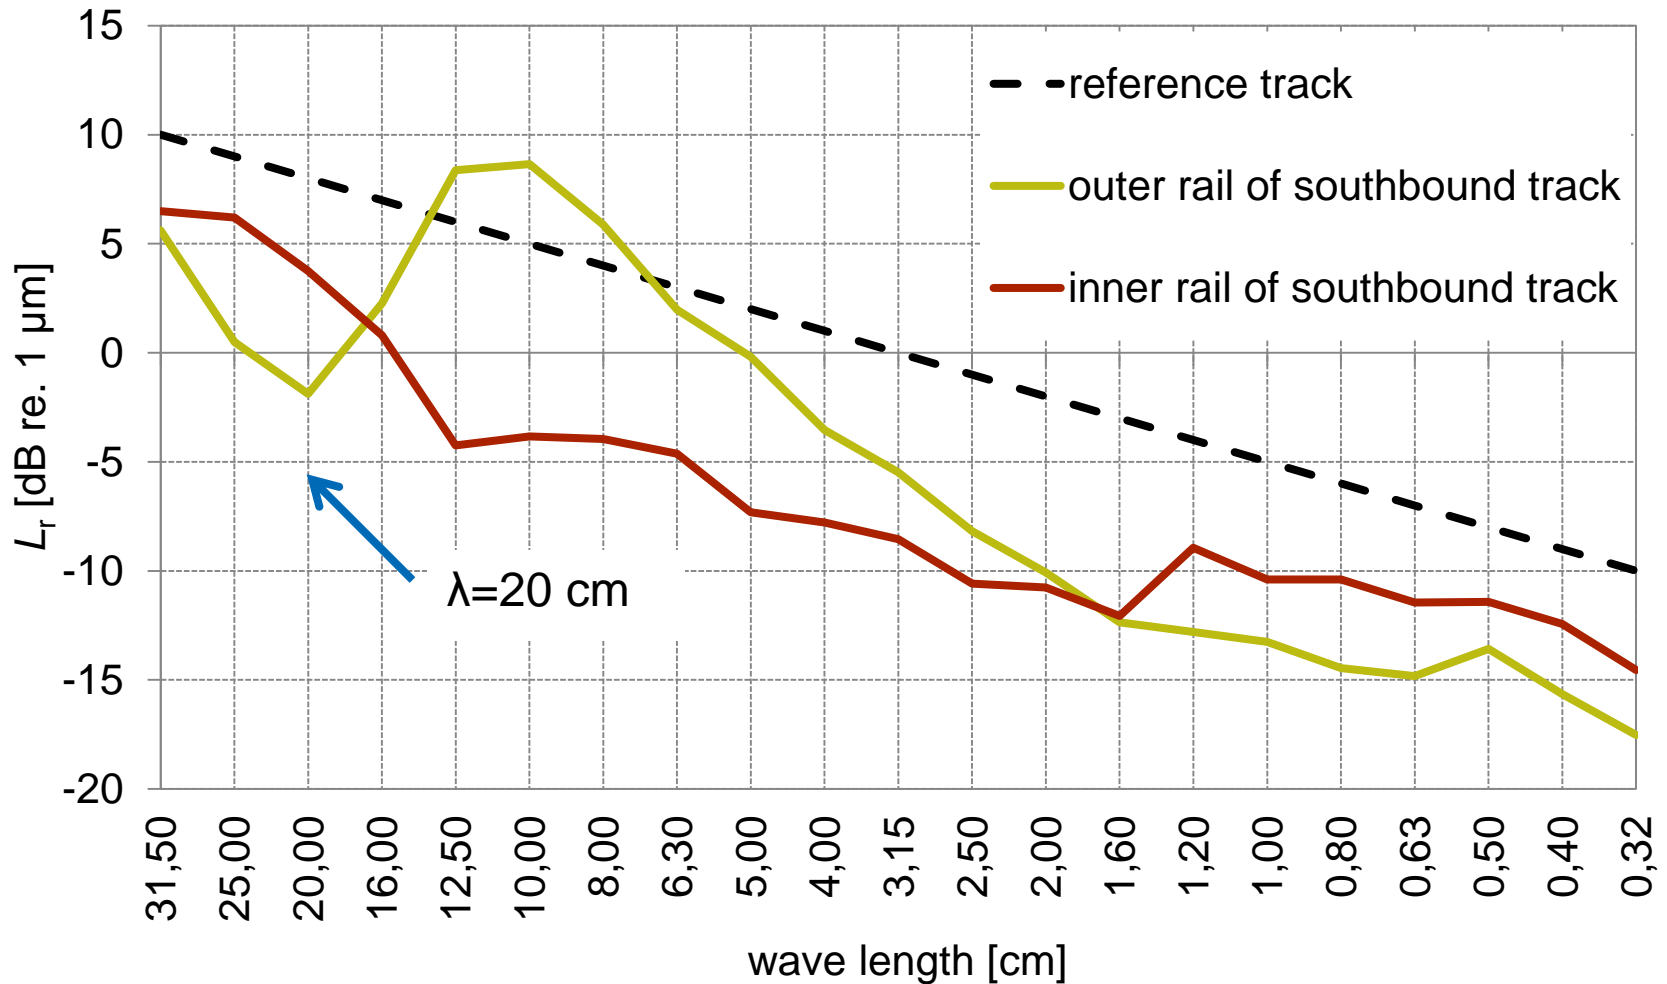
Rail roughness measurements (2/2)

Measurements done prior to rail head grinding

- 80 Hz at 60 km/h, thus $\lambda=20$ cm
- no peak at 20 cm that explains noise at 80 Hz
- no decrease in complaints after rail head grinding (Jan 2014)
- rail roughness is probably not the cause of nuisance
