Mechanisms of acoustic aging of road surfaces

Ronald van Loon
Christiaan Tollenaar
Gijsjan van Blokland
M+P Consulting Engineers, Vught, Netherlands.

Summary

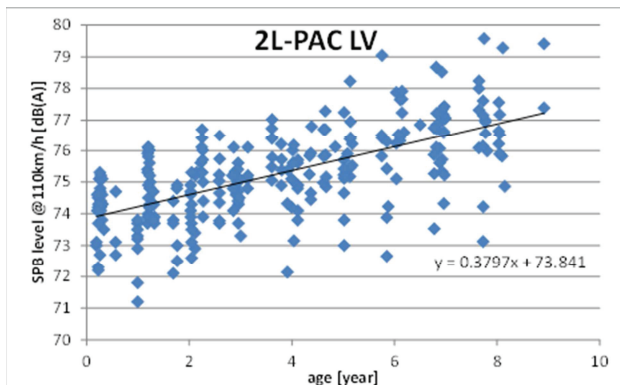
Figure 1. Example of a series of repeated SPB measurements (light vehicles) on 2L-PAC on several locations on Dutch highways. In total the data set covered nine years and are distributed over more locations.

detailed and repeated SPB measurements for both light vehicles and heavy vehicles on several test locations on the Dutch highway system over a period of 8 to 9 years. In Figure 1 results of repeated SPB-measurements on 2-layered porous asphalt (4/8 top layer) on several locations in the Netherlands are given as a function of age of the surface.

The surface type 2L-PAC was of special interest in the Dutch IPG research program and sample data is available from repeated tests over a period of 8 year at several locations. On average a deterioration of 0,38 dB/yr was observed (see Figure 1) but variations between 0,15 and 0,60 dB/yr were observed. An example of an excellent performing surface and an example of a less optimal performing surface are given below (Figure 6). For the sections on the A28, near Staphorst, the deterioration is explained mild texture degradation with mild filling up of the porous layer. For the A30, near Ede, the spectral worsening can be explained by clogging of the pores, leading to both, a strong degradation of the absorption characteristics and increase of flow resistivity.

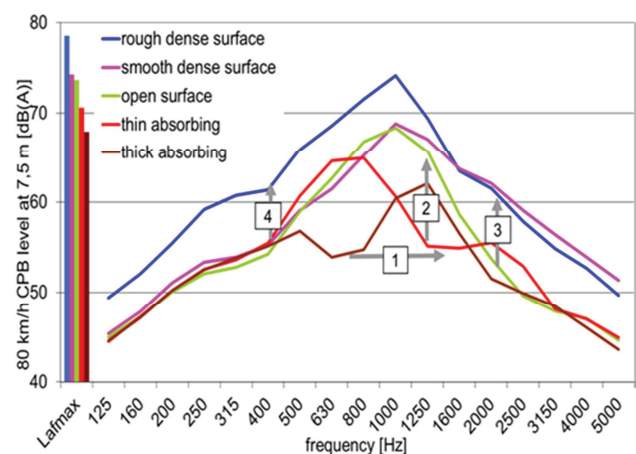
Figure 2. Spectral distribution of the different aging processes: (1) filling up of the lower layer, (2) further filling, (3) clogging of top-layer and (4) stone loss. Spectra are representative for car tyres.

- Effect of surface texture leads to variation in the low and mid frequent part of the spectrum. The frequencies above 1250 Hz are hardly affected. (*compare the rough dense surface with the smooth dense surface*).
- Effect of a closed versus an open surface (actually low and high flow resistivity) is found at frequencies above 1000 Hz. In this case the lower frequencies are hardly affected. (*compare the smooth dense surface with the open surface*).
- Creating an open layer of a certain thickness introduces acoustic absorption. (*compare the open surface with the thin absorbing*).
- Increasing the thickness of the absorbing layer causes a shift of the absorption “dip” to lower frequencies. (*compare the thin absorbing with the thick absorbing*)

Aging is actually reversing the mentioned processes. The numbers 1 to 4 shown in the graph (figure 2) indicate the type of change:

(1) and (2) Filling-up of the acoustic layer by dirt will cause a reduction of the thickness of the effective absorption layer and thus a shifting of the absorption “dip” to higher frequencies. Eventually nearly total clogging of the porous layer will cause loss of acoustic absorption causing an increase in the mid frequency range.

(3) Closing of the top layer by either extensive dirt or compaction of the slightly open top layer amplifies aero-acoustic noise generation and thus increases levels at the mid and high frequency range.

(4) Degradation of the surface texture through stone-loss amplifies texture induced vibration of the tyre structure, that manifests itself in the lower and mid frequency range.

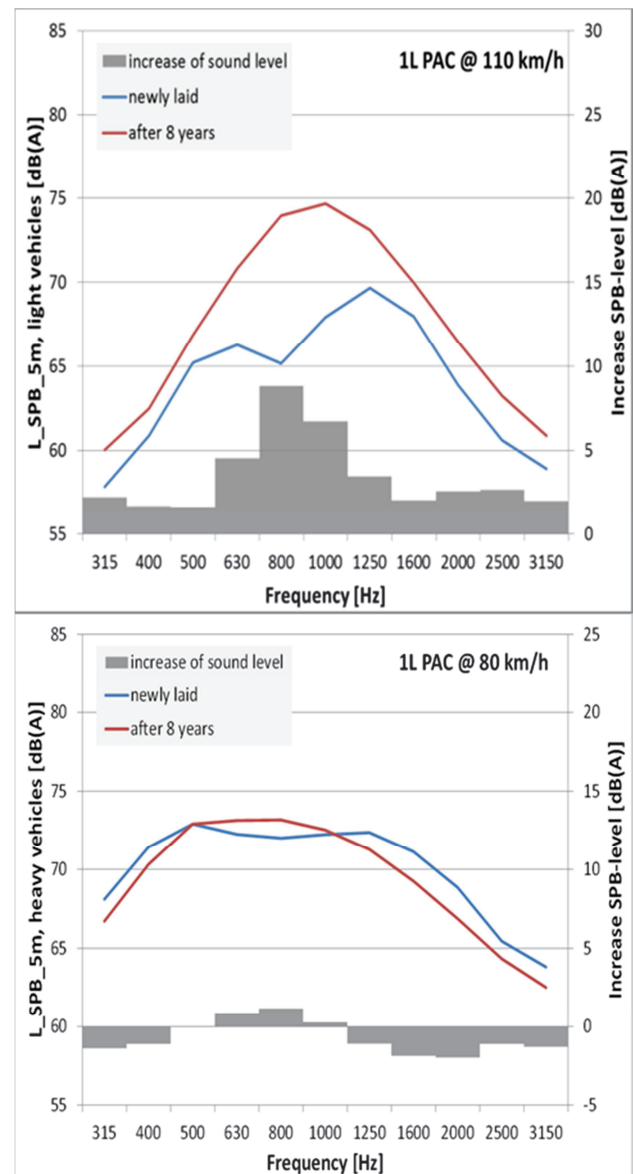
Figure 3. Spectral composition of the SPB-results for LV's at 110 km/h on a 1L-PAC 0/16 in the Netherlands. Top: the repeated measurements during a period of eight years. Bottom: initial and final spectra and their mutual spectral differences based on trend analysis. The initial and final spectrum is determined from the regression line through each 3rd-octave band. The bar graph represent the total increase in each frequency band over the period of eight years.

All one-third-octave band data of the 7 test sections are combined into a regression diagram as a function of age and the best fitting linear function is determined. From this function the initial and 8 yr. value are calculated. The resulting

graph is presented in figure 3 top for LV's and bottom for HV's.

The spectral change of 1L-PAC for LV's follows a characteristic pattern. In the low frequency range, levels remain more or less the same and a slight increase is observed at the high frequency range. The largest change is observed in the mid

frequency range. This spectral change indicate an acoustic aging process that mainly is caused by clogging of the pores evenly over the thickness of the porous layer eventually also leading to clogging of the top. The texture remained about the same.

For HV's a different change is noticed. The increase in the mid frequency range is much smaller but surprising is the decrease low and high frequencies. No explanation can be given to this.

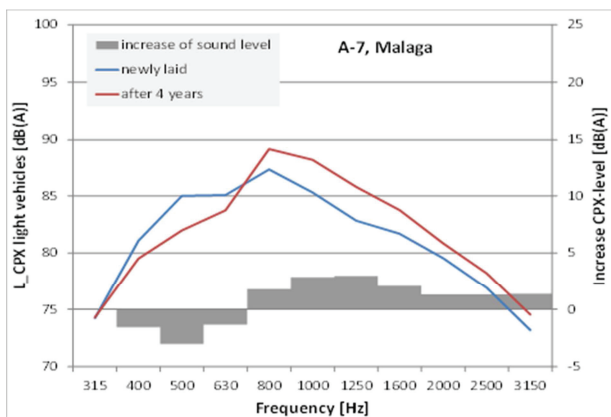
Figure 4. Spectral composition of the CPX-results for the SRTT-tyre on a 1L-PAC in Spain.

The results of the repeated measurements with the CPX system on the A-7 near Malaga (Spain) display a different development. Increasing sound levels at the higher frequencies (800-3150 Hz) and decreasing sound levels at the lower frequencies after four years. The increase is probably due to clogging of the top layer. No explanation can be found for the decrease at lower frequencies, other than that traffic has smoothed the texture over time.

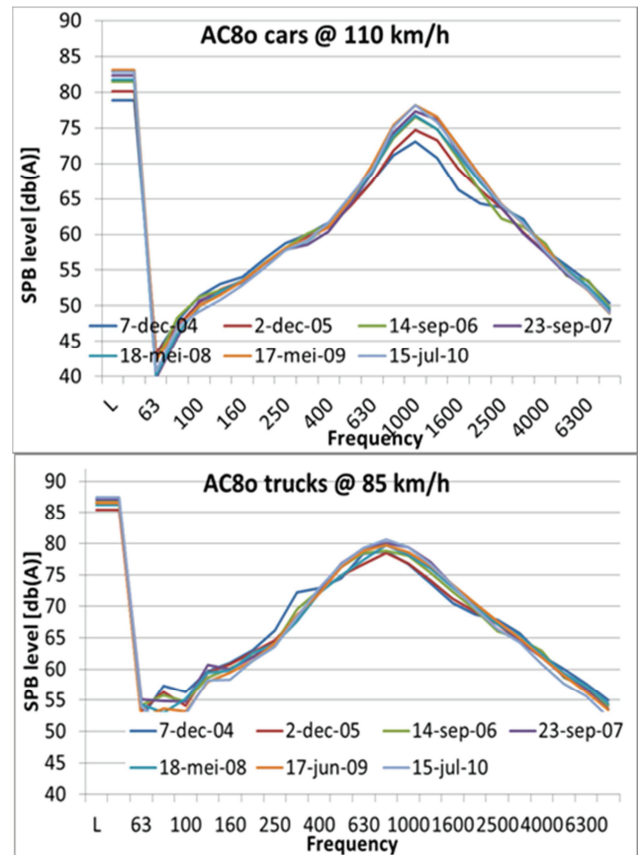
Figure 5. Results from repeated SPB measurements on the highway M10 test location with AC8o (=1L-PAC8). Top: light vehicles, bottom: heavy vehicles.

The data from the Danish tests for LV's and to a lesser extent for HV's follow the Netherlands trend but its effects are less visible in the spectra. One can notice a filling up of the indent at around 1600 Hz (see Figure 5). The increase at around 1000 Hz can also be attributed to this loss of acoustic absorption, but possibly some texture degradation is also present in the frequency range.

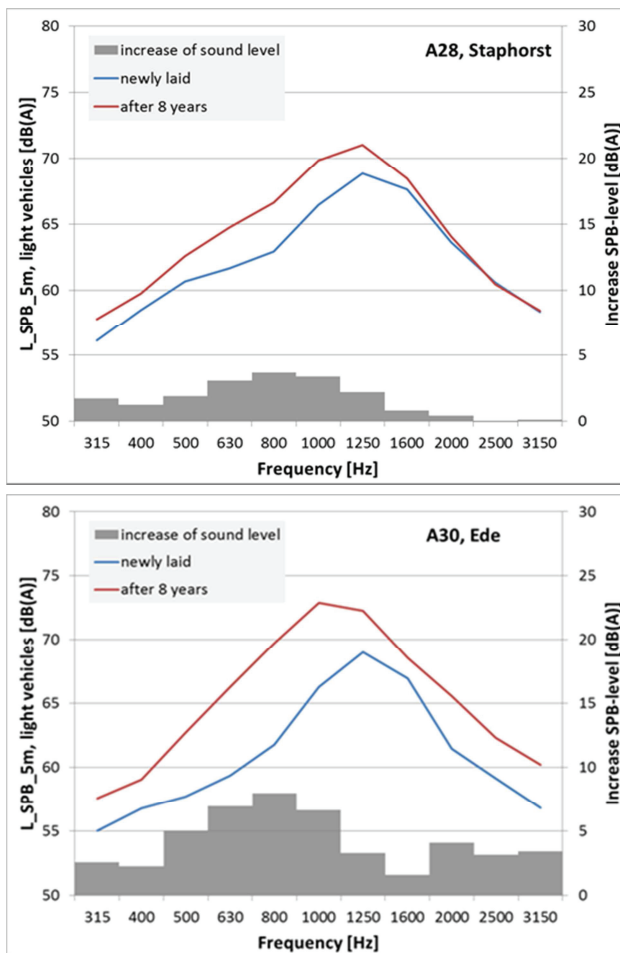
Figure 6. Examples of spectral distribution of aging of 2L-PAC on two locations. Top A28 near the village of Staphorst, bottom the A30 near Ede. Each graph displays the initial spectrum and the spectrum after eight years, based on regression analysis. The bar graph represent the increase in each frequency band after eight years. Each graph displays the average over six test sections on each location.

Study of the spectral trends over age show that the main effect for LV's and HV's is the filling up of the open surface, leading to loss of acoustic absorption.

to explain variation. However the best performing surface in Figure 6 also had the highest HV intensity. Other factors, still unknown, are to be taken into account.

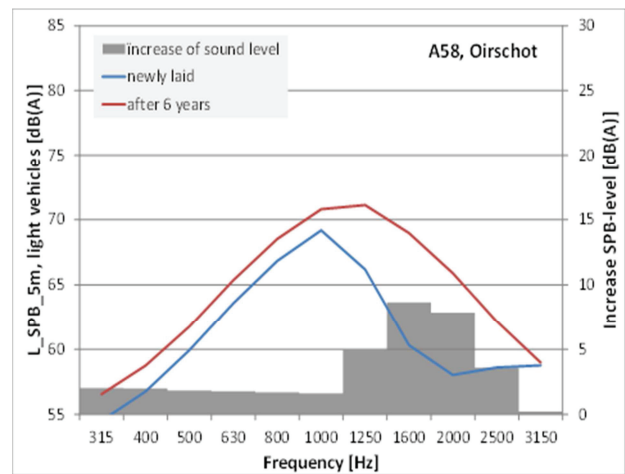
Figure 7. Spectral distribution of aging of a thin surface layer (A58, Oirschot, Netherlands). Each graph displays the initial spectrum and the spectrum after six years, based on regression analysis. The bar graph represent the increase in each frequency band after six years.

The typical acoustic degradation of thin surface layers is shown by the examples in Figure 7, the A58 near Oirschot (NL) and Figure 8, the M10 near Solrød (DK). Thin surface layers are not high absorptive road surfaces such as 1L-PAC and 2L-PAC. For thin surface layers the increase of flow resistance is the main cause of degradation. It is caused by either extensive dirt or compaction of the slightly open top layer. This process lead to an increase of sound levels at the mid and high frequency range (1000-3150 Hz).

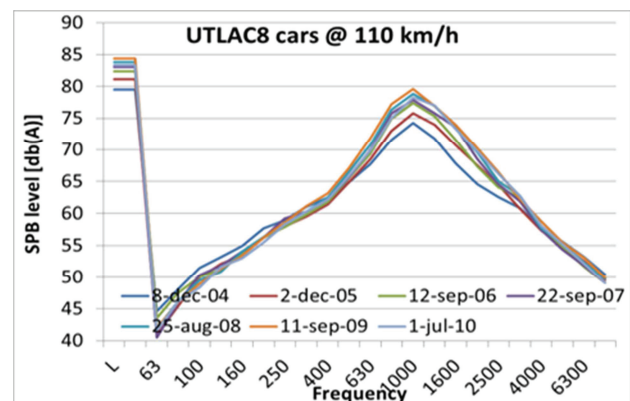
Figure 8. Spectral distribution of aging of a thin surface layer (M10, Solrød, Denmark). This graph shows the results of SPB-measurements over a period of seven years.

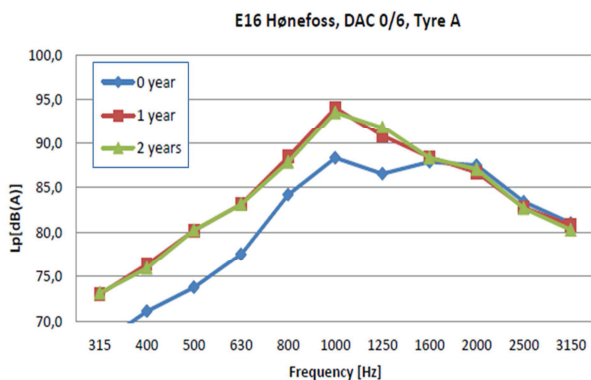
Figure 9. Spectral distribution of aging of a dense asphalt concrete 0/6 (E16, Hønefoss, Norway). This graph shows the results of CPX-measurements repeated after one and two years [4].

The winter conditions in Scandinavian countries are severe. Low noise surfaces such as TSL and PAC are too vulnerable and the focus is on dense asphalt surfaces with a small maximum aggregate size (0/6 and 0/8). On the Highway E16 several test sections with dense asphalt concrete (DAC) with variable aggregate sizes are constructed and annually measured by the CPX-method. A dense surface has no acoustic absorption. The only acoustic aging effect that will be found is the degradation of the texture. In Figure 9 the aging of the DAC 0/6 test section is shown.

Right after the construction, before the first winter season, amplitudes below 1600 Hz are considerably lower than in the later stage. After the first winter season, the increase of the sound levels is likely related to the roughening of the surfaces. In the Nordic countries the service life of road surfaces is much shorter than on the European mainland. This is caused by a wide use of studded tyres during the winter in the Nordic countries.
