Complaints about vibration-induced noise from the underground metro line in Amsterdam

Edwin Nieuwenhuizen

Rail Technology Conferences 2014
Düsseldorf

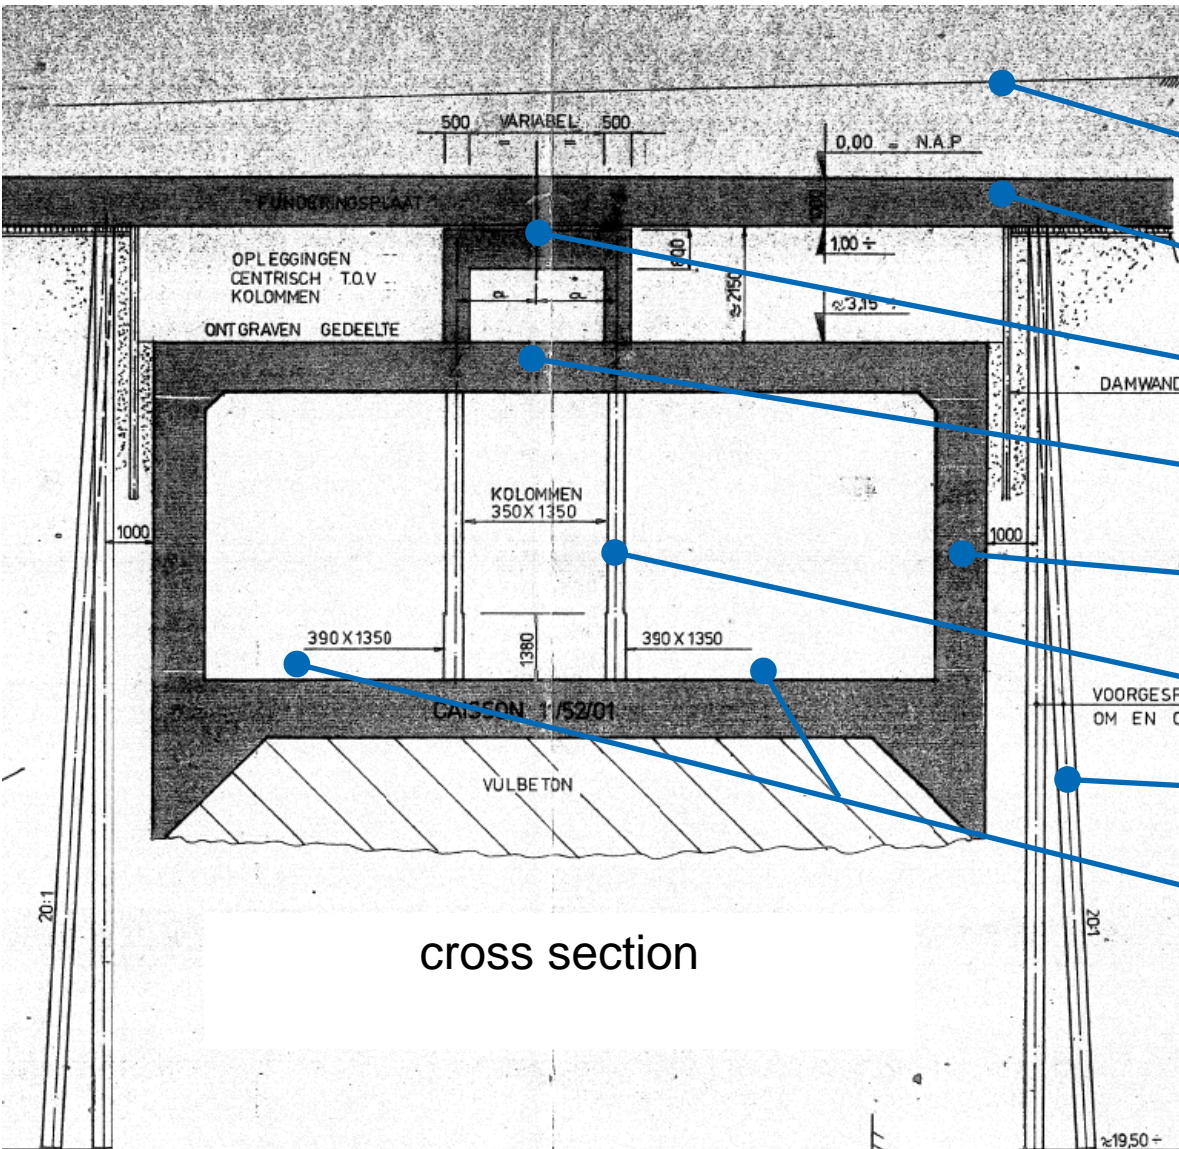
Tunnel structure example

- ground level
- building foundation
- support beam
- caisson deck
- caisson wall
- concrete column
- concrete piles
- 2 ballasted tracks

cross section
